A Study of Overall Tribological Problems in Developing R407c Rotary Compressor with Polyolester Oils

A STUDY OF OVERALL TRIBOLOGICAL PROBLEMS IN DEVELOPING R407C ROTARY COMPRESSOR WITH POLYOLESTER OILS

Sung Hoon Choa, Chung Guk Baek, Yoon Won Kim, Kwang Soo Hyun, Sang Kyung Oh
Samsung Electronics Co. Ltd, Suwon Korea

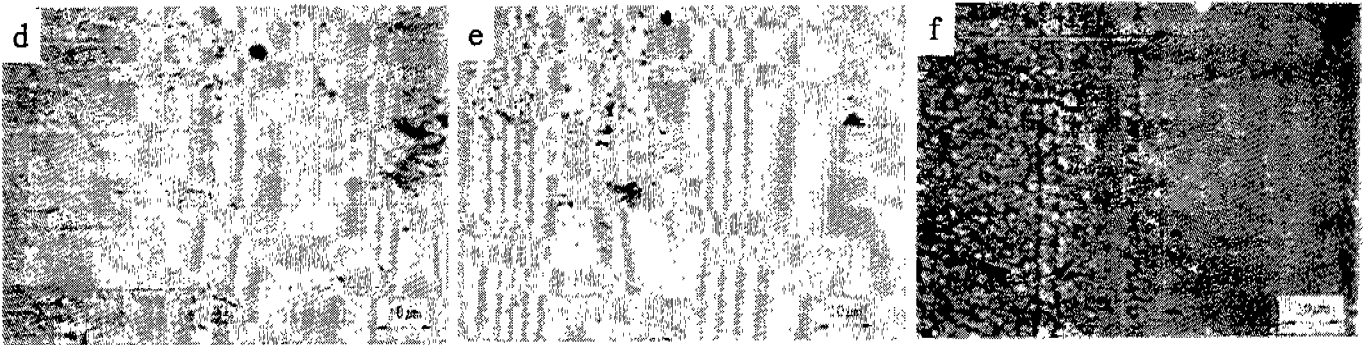
Original Surface | Worn Surface Original Surface | Worn Surface Original Surface | Worn Surface

Fig. 8 SEM pictures of the wear on the vane for various coating
(a) TiN_I, (b) TiN_II, (c) TiAlN, (d) DLC₂ (e) DLC₁ (f) Ion Nitriding

The worn surfaces of the vane and the disk was examined with SEM and EDX. SEM pictures of vane wear scar was shown in Fig.8. Compared to the unworn surface, generally the wear surface became more smooth. For TiN_I coating, the worn surface is very smooth. However, the fracture of coating was occurred in some areas as shown in Fig.10. Even though not shown in this paper, the edge of contact area becomes sharp for the test without oil. For TiN_{II} coating, the large grooves were produced and EDX analysis showed no trace of Ti in the grooves, indicating the coating was spalled off. For TiAlN coating, the original coating exhibits a rough surface topography, and edge of worn surface is very sharp. As shown in Fig.11, the wear particles embedded in the edge of contact area were observed. Those rough surface and hard TiAlN wear particle entrapped between contact surfaces may be responsible for high friction. EDX analysis also revealed that coating was removed extensively. DLC₂ coating showed much low wear and friction. SEM pictures of the worn surface exhibited very smoothening of asperity. EDX analysis of the disk surface, the mating surface, showed that the carbon was transferred to disk surface and formed a easily shearable tribo-film which gives low friction and consequently contributes low wear. However, plate-like spalling of coating in some areas was observed as shown in Fig.12. This is a kind of delamination fracture which is caused by propagation of cracks running parallel to the surface, at the interface between coating layer and substrate under action of the repeated cyclic stress. It is attributed to poor adhesion between coating and substrate. The worn surface of DLC₁ vane show similar wear type with that of DLC₂ which is consisted of smooth surface and spalling of coating. However, DLC₁ coating did not provide enough wear resistance compared to DLC₂. Ion nitride did not show sharp edge either embedded wear debris on the worn surface. The SEM pictures of the vane cross section (not shown in this paper) exhibited several cracks perpendicular of the sliding direction in the nitride surface layer, indicating that durability of ion nitride layer is not enough to sustain cyclic contact stress. Carbon vane which is softer than the roller was worn much despite of good lubrication property. Those loose wear particles will be collected around the molecular seive, resulting in deterioration of the molecular seive.
